REPORT OF INVESTIGATION

**Fatal Powered Haulage Accident
October 31, 2017**

**Marigold Mining Co.
Marigold Mine
Valmy, Humboldt County, Nevada
Mine ID No. 26-02081**

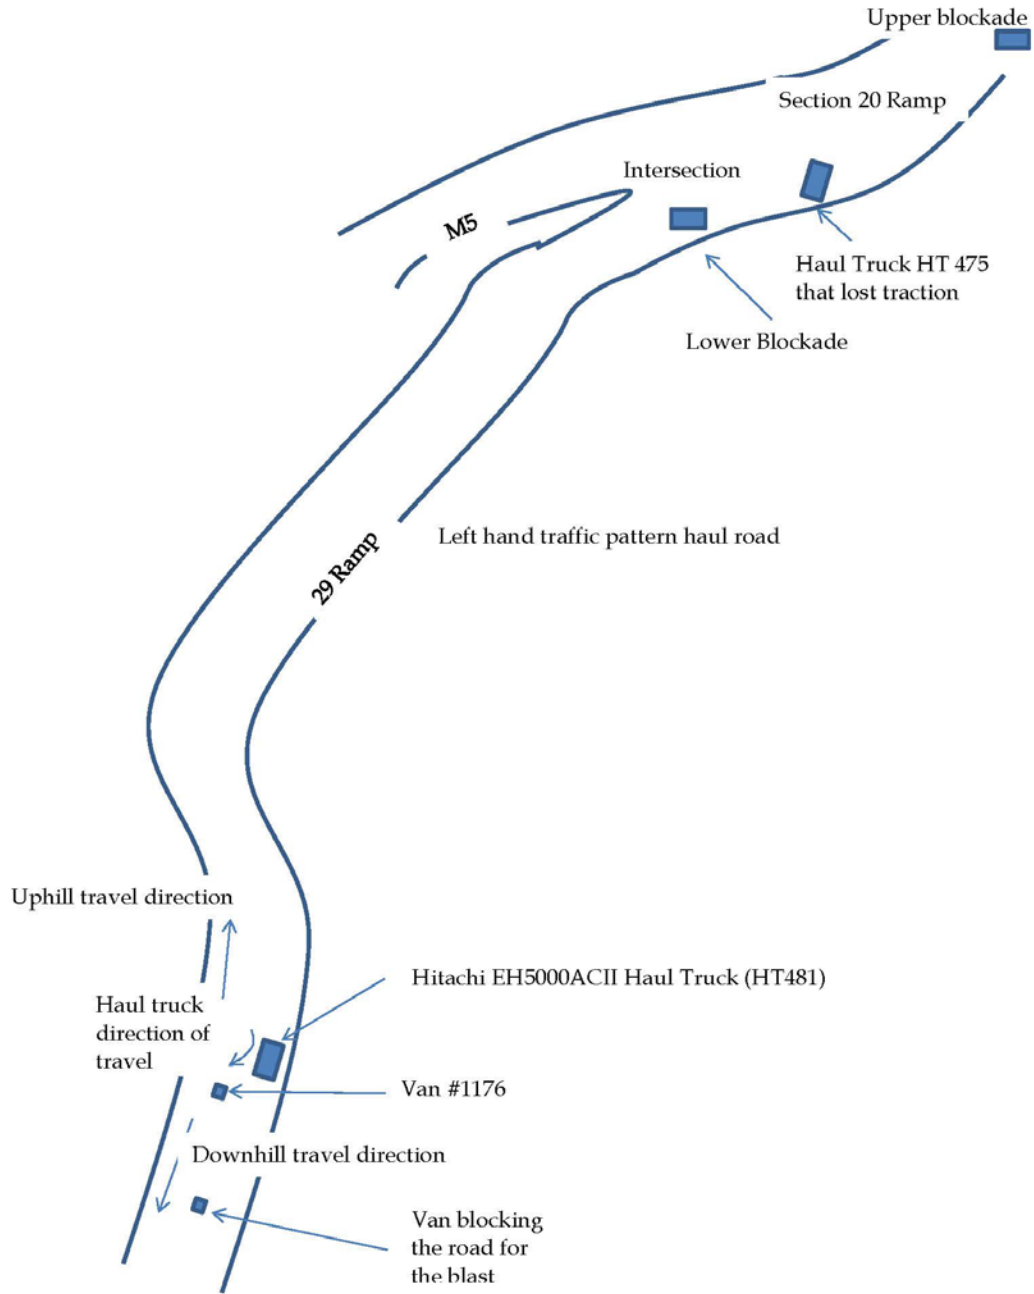
Figure 1: Overview of accident area (not to scale)

The accident occurred on the 29-ramp, which is a section of the road between the Mackay 2 pit and Section 20 facility. Both van #1176 and haul truck #481 were parked on a 6% downhill grade, facing southwest, toward the pit. The roadway was dry, hard packed earth and appeared well maintained.

According to witness accounts, the passenger van stopped along-side the Hitachi truck about 20 feet away. Investigators concluded the van was slightly farther down the haul road than the haul truck since the front of the van was in the turning radius path of the front right tire. Investigators were not able to determine the precise location where the van stopped relative to the truck.
