REPORT OF INVESTIGATION

**Dredge Non Metal Mine
(Sand)**

**Fatal Powered Haulage
April 12, 2018**

**Rye Dredge & Plant
Trinity Materials, Inc.
Cleveland, Texas
Mine ID No. 41-02547**

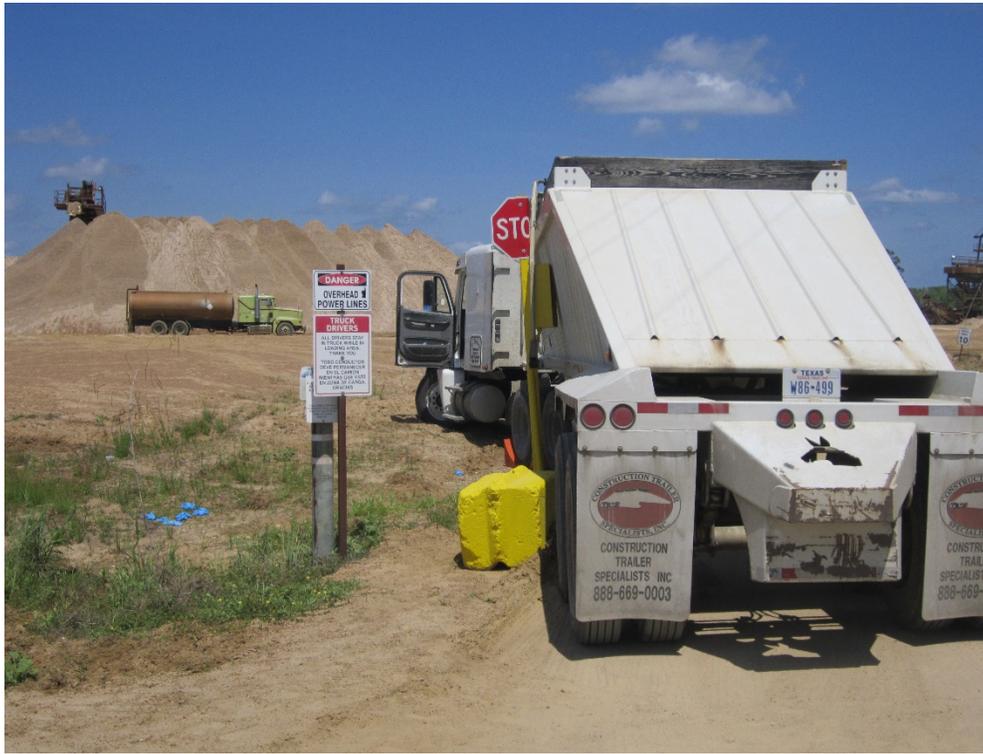
Manuel G. Rodriguez, a 59 year old customer truck driver, received fatal injuries on April 12, 2018, when he fell from his truck and was run over by the truck's rear wheels. Mr. Rodriguez was attempting to scan a card that identifies customer trucks entering the facility to load material. Investigators believe Mr. Rodriguez approached the Apex Express Radio Frequency Identification Card Reader (RFID) but positioned the vehicle too far away from the RFID to scan the card from inside the truck. Investigators conclude Mr. Rodriguez removed his seatbelt, opened the driver's side door, and leaned out of the cab with his right foot on the clutch pedal and the truck in gear. The truck moved forward, causing him to fall out.

The accident occurred because the victim did not properly secure the truck by setting the parking brake and putting the vehicle in park before opening the door and leaning out of the truck.

Corrective Action: The mine operator has discontinued the use of the RFID system and in the future will be using handheld and CB radios for communications with customer truck drivers. Site specific training now includes instructions to visitors advising them to set park brakes and place equipment in the park position prior to leaving the operator's cab.
